NASA TM X- 55516

# LOCALIZED OVERHEATING IN AEROBEE REGENERATIVELY COOLED THRUST CHAMBERS

JON R. BUSSE  
PAUL S. BUSHNELL, JR.

GODDARD SPACE FLIGHT CENTER  
GREENBELT, MARYLAND

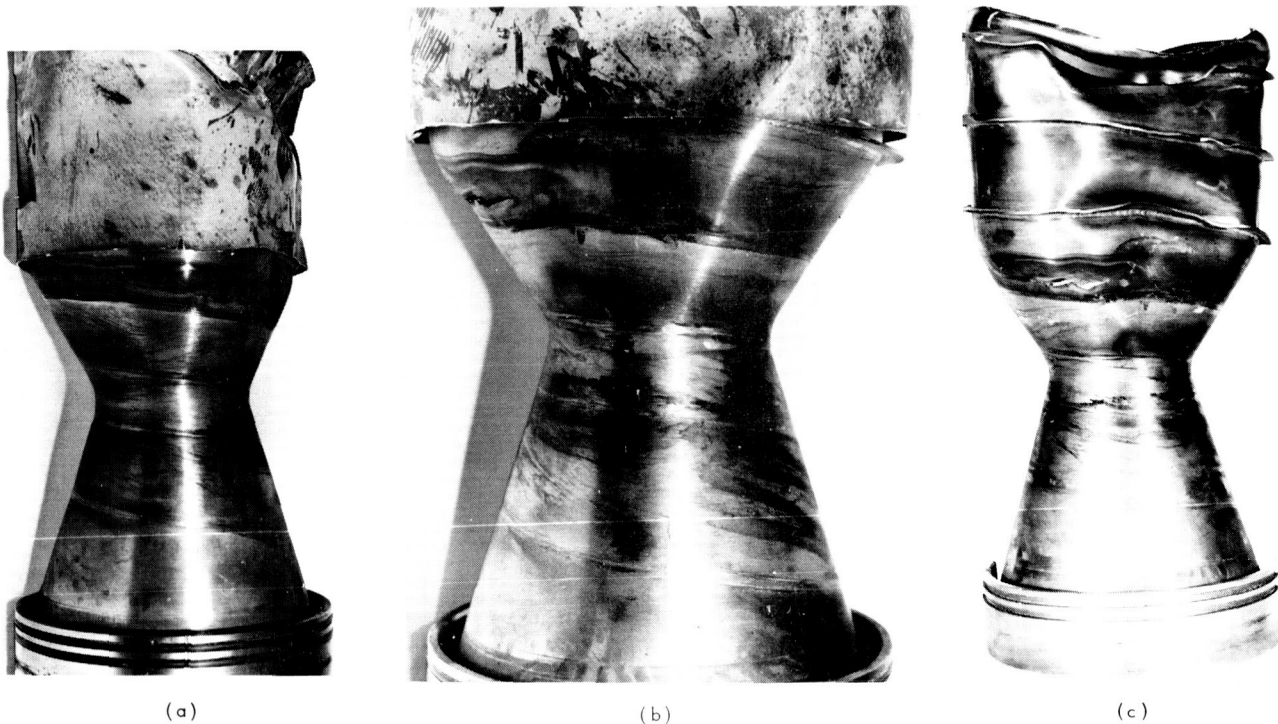
Figure 3a shows an external view of the burned-through portion of convergent section of the nozzle of 4.126 GG. Most of the outer skin of the regenerative jacket and the entire assembly (Figure 1) have been removed. The fit marks where the sleeve assembly bears on the chamber assembly are clearly noticeable. Note the helical pattern and the extreme burned condition of the metal adjacent to the hole. Figure 3b shows another view of the motor taken at approximately 90° from Figure 3a. Here, the heat-affected zones on the convergent section and the aniline-furfuryl (ANFA) resin deposits covering the convergent and divergent sections are apparent as well as the burned-through area. The external photograph of the chamber in Figure 3c shows the injector, jacket, and sleeve assembly removed. The distortion on the forward end is due to the free-fall impact of the sustainer, rather than the burn-through.

Figure 3—External photographs of NASA 4.126 GG burned-through thrust chamber: (a) jacket partially cut off; (b) chamber turned 90°; (c) jacket, injector, sleeve assembly cut off.

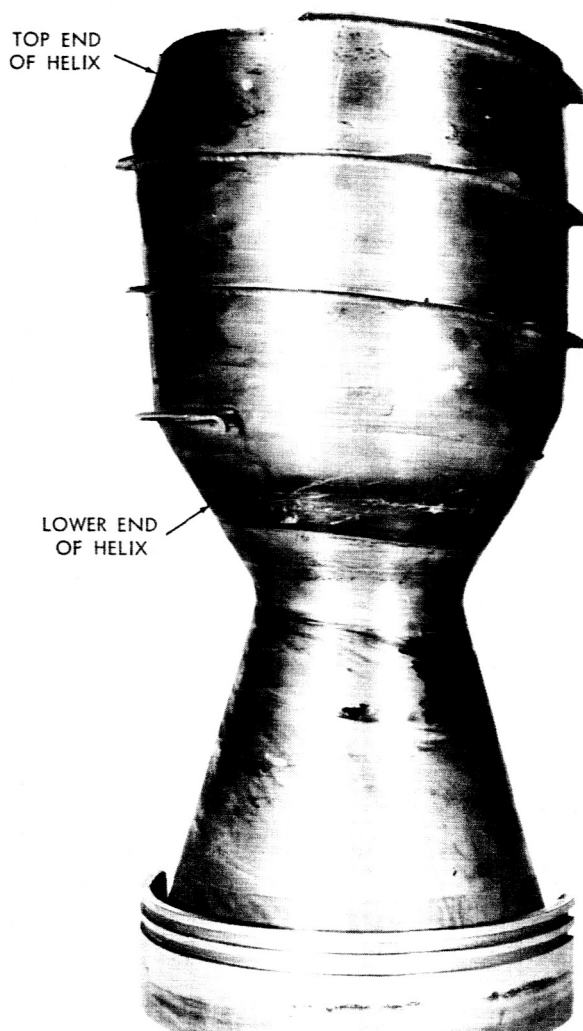
Figure 4 shows the opposite half of the thrust chamber (rotated 180° from Figure 3a). This view shows some heat-affected area and burned fuel deposits, but no burn-through. The welded portion of the helix can be seen at the top of the section. The welded helix mates with the sleeve assembly at the bottom of the helix at the point as shown in the figure. Figure 5 provides an excellent close up external view of the burned-through nozzle area. Observe the erosion of metal around the burned area, the result of high velocity flow of the combustion gases.

Figure 4—Thrust chamber rotated 180° from Figure 3a.

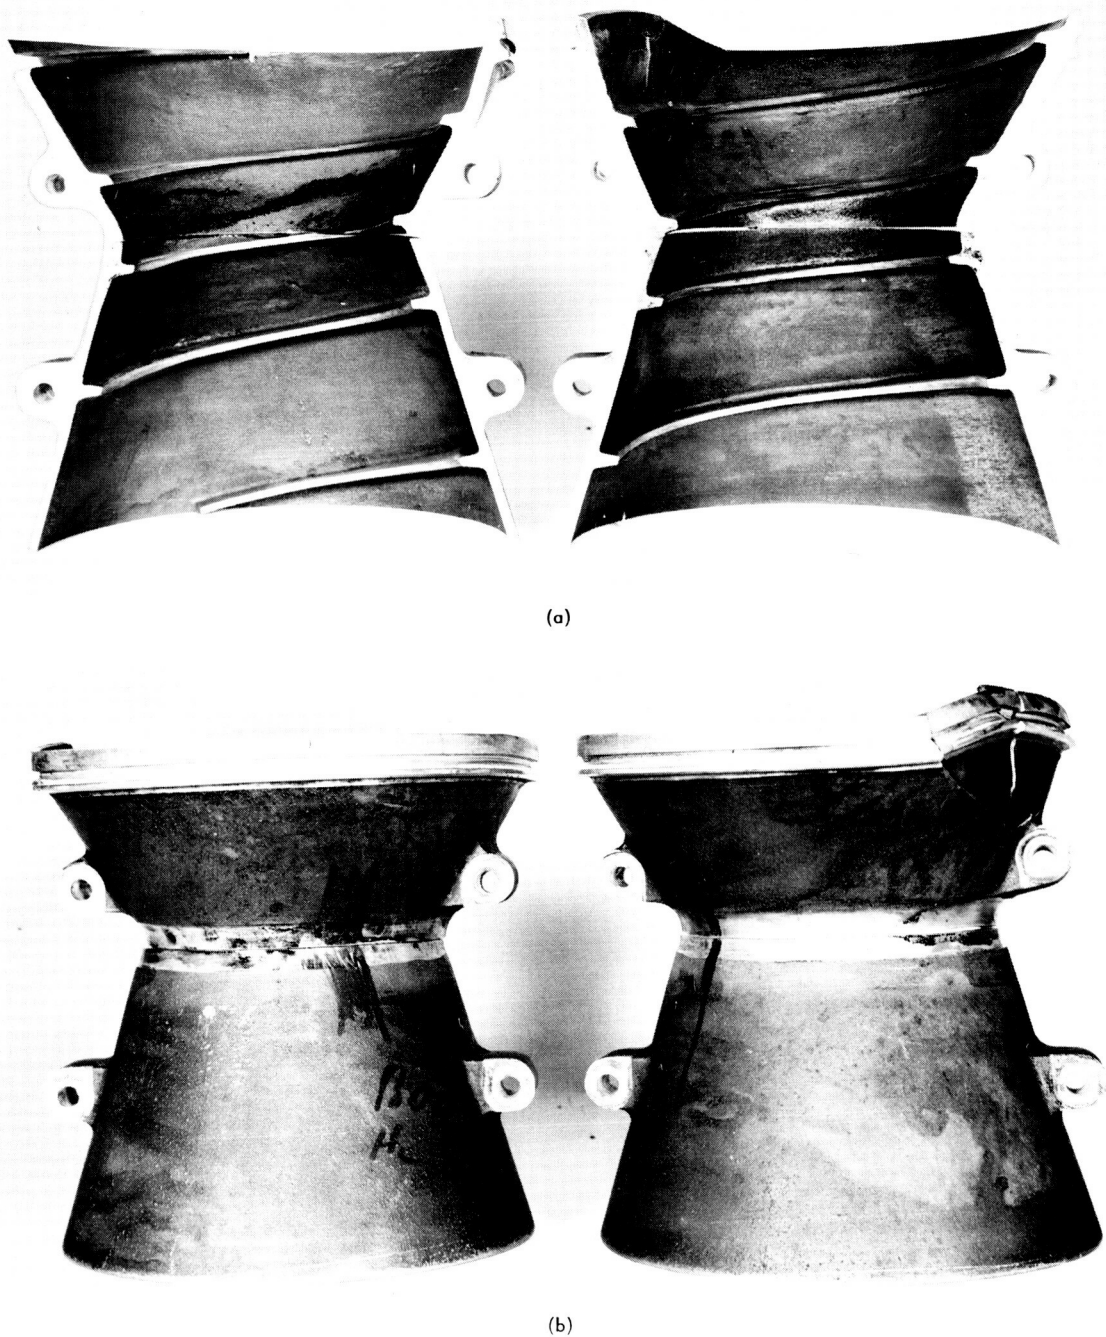
Figures 6a and 6b are internal and external views of two of the four magnesium filler blocks which make up the sleeve assembly. Note the helix passage (in Figure 6a) which fits against the thrust chamber nozzle. It is through this passage that the ANFA flows during burning. The broken piece shown in Figure 6b is due to impact.

Figure 6—Magnesium filler blocks: (a) internal view; (b) external view.

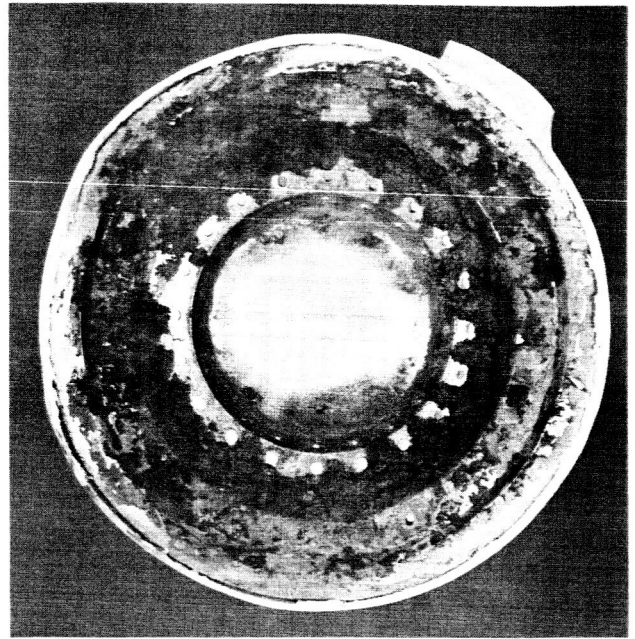
Figure 7 shows the thrust chamber injector head. The outer ring of the orifices are for the oxidizer. The orifices for the fuel (much less noticeable) are inside the outer ring of the oxidizer orifices. The fuel holes are drilled in the frustum of a cone which projects into the thrust chamber. Both sets of holes are canted to produce impinging propellant jets in the thrust chamber.

The holes were determined to have been properly drilled on this chamber. The carbonaceous material on the face of the plate (visible in the figure) is a normal product of the propellants; however, the amount in this instance is excessive, presumably the result of a fuel-rich mixture ratio under which the chamber operated for a short time after the burn-through occurred.

Figure 7—Thrust chamber injector head.

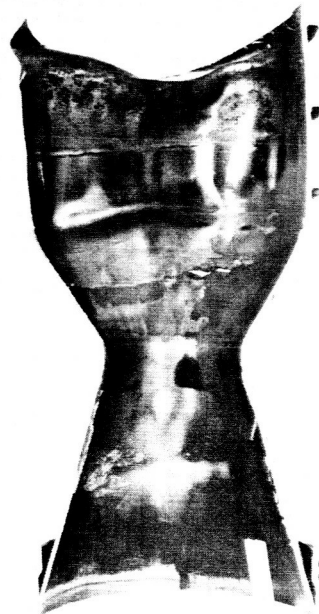
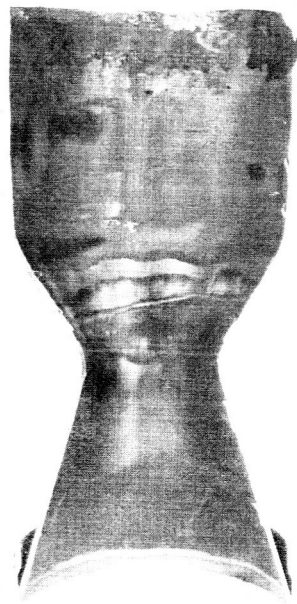
Figures 8 and 9 are internal views of the sectioned thrust chamber. Notice that the carbonaceous deposits (Figure 8b) are especially heavy on the side opposite the area where the burn-through occurred. Figure 9 is a closer view of the convergent section of nozzle area opposite the burned-through spot. Some erosion is evident on the left of the picture. In the upper

Figure 8—Thrust chamber cut in half: (a) internal view showing burned-through side; (b) internal view, opposite side.

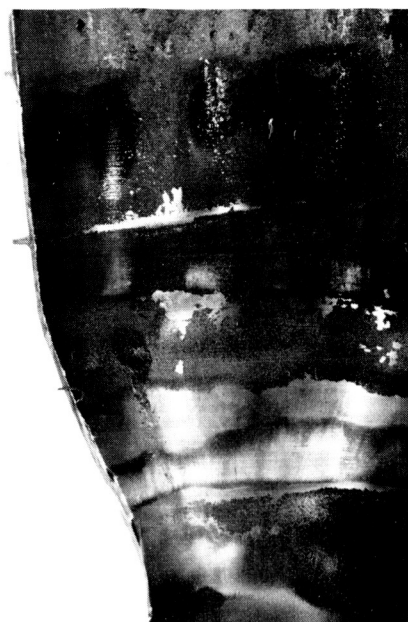
left of the figure two segments of part of the regenerative jacket helix can be seen. These are welded to the combustion chamber.

Figure 9—Close-up, internal view of thrust chamber.

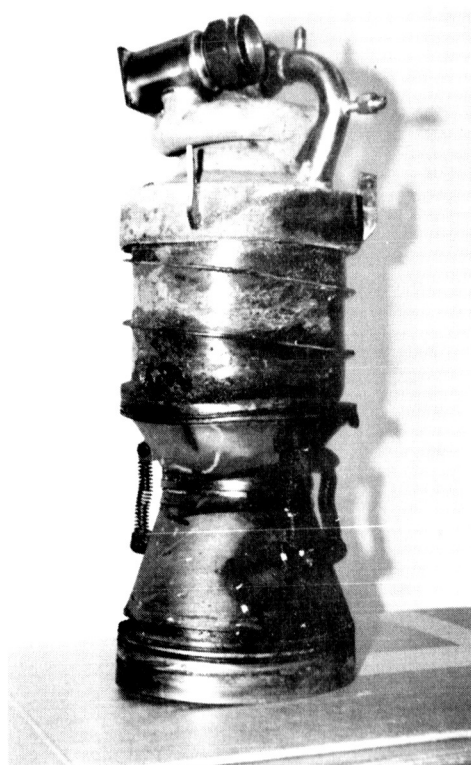
Figure 10 shows the thrust chamber of NASA 4.114 GG with the outer skin of the regenerative jacket removed. The deposits shown in this figure are a combination of mud, rust and aniline - the results of approximately two months underwater. Figures 11a and 11b

Figure 10—4.114 GG thrust chamber before cleaning, throat blocks on.

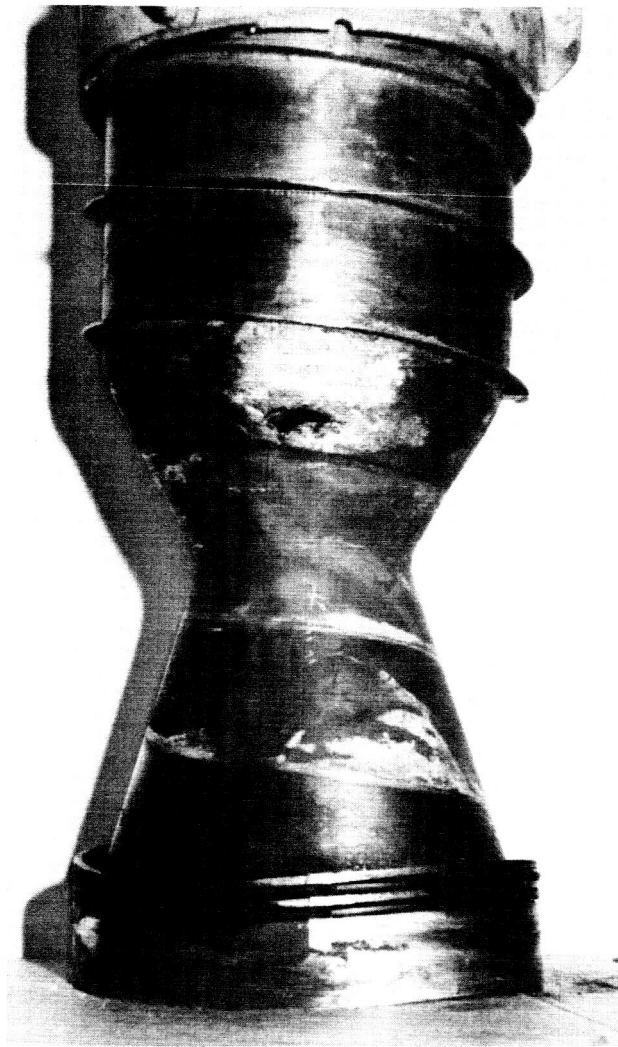
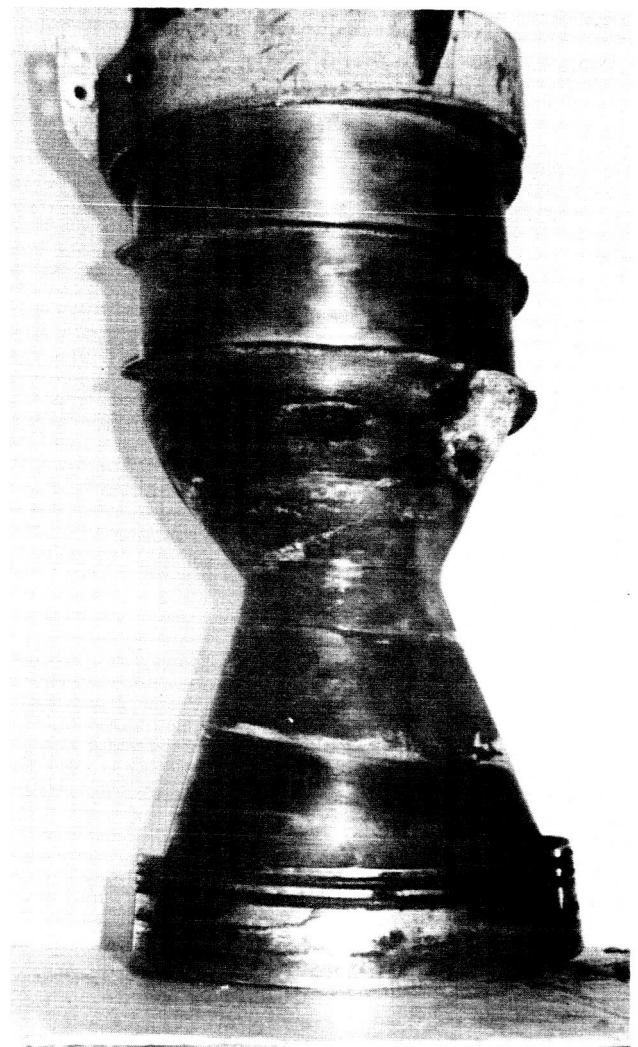
Figure 11—External views of 4.114 GG thrust chamber: (a) 0° view of burned-through nozzle; (b) 90° view of burned-through nozzle.

are views of the thrust chamber approximately 90° apart. Again the rust and aniline-furfuryl alcohol deposits are clearly evident. The burned-through spots are easily seen.

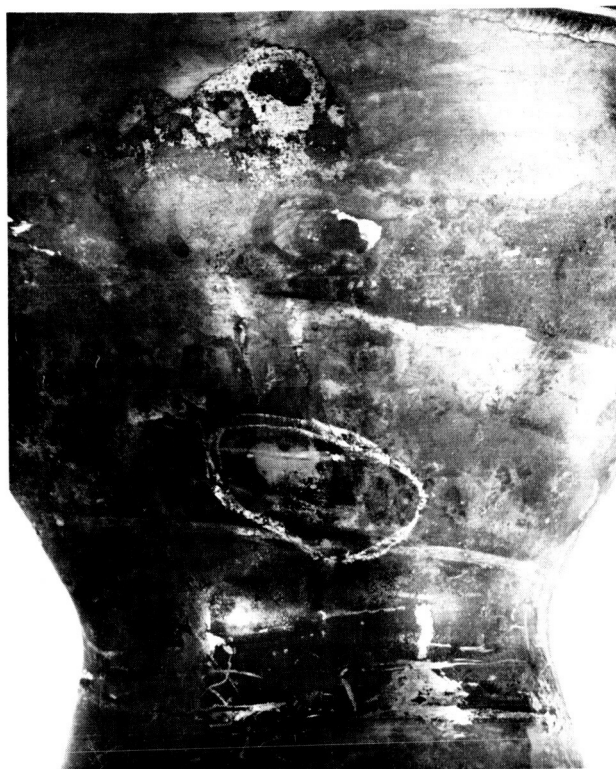
Figures 12 and 13 are external close-up photographs showing burned and burn-through areas.

Figure 12—Close-up external view of burned area on 4.114 GG thrust chamber.

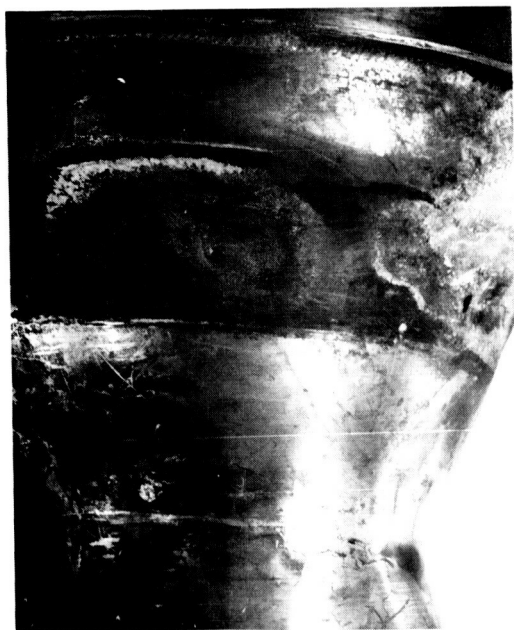
Figure 13—Close-up external views of burned-through areas on 4.114 GG thrust chamber.

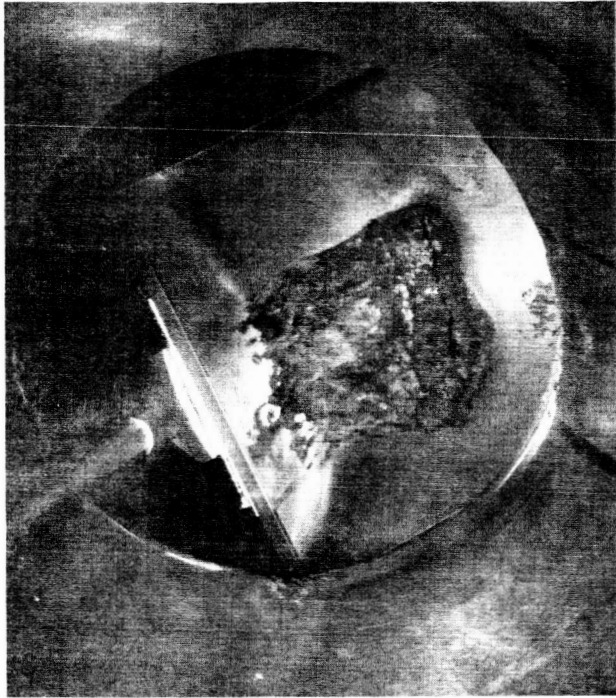
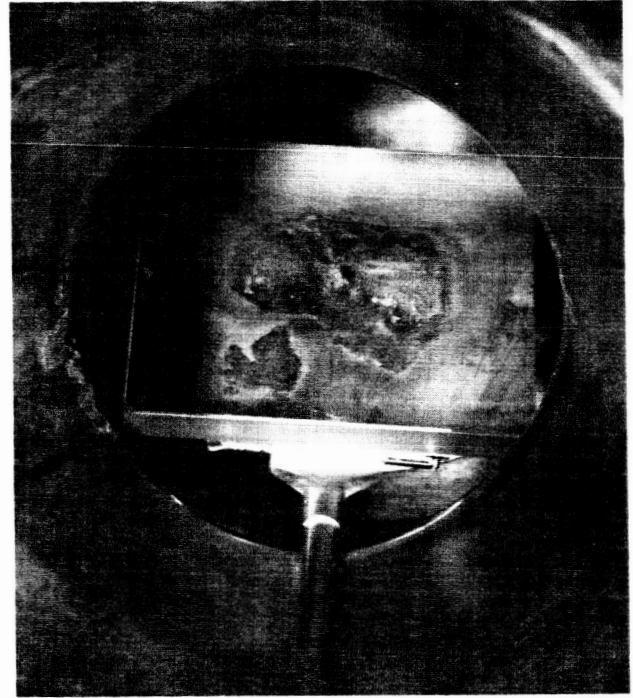
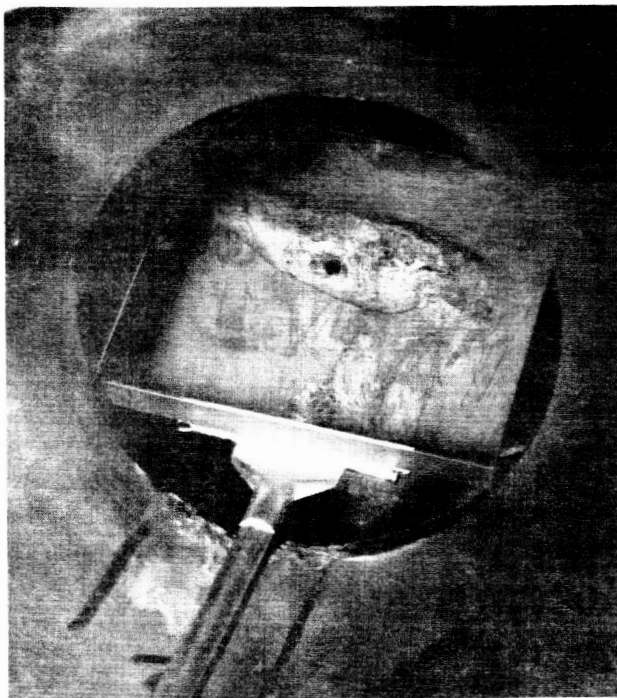
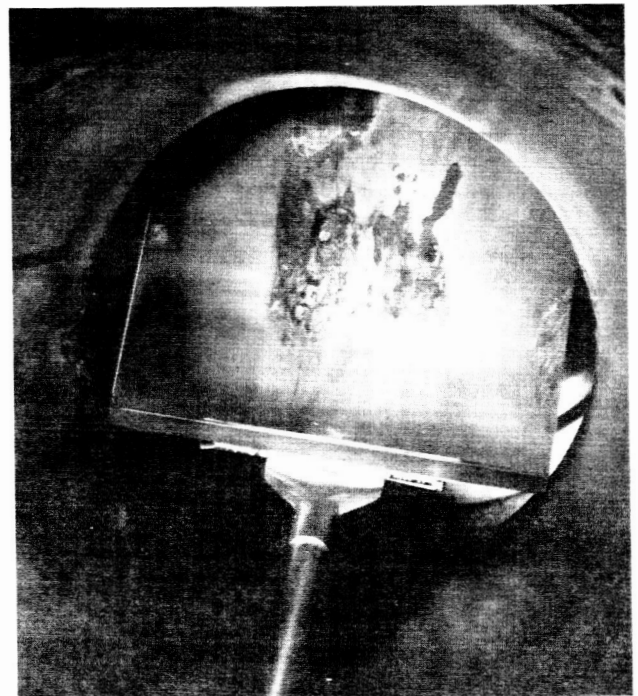
Figure 14 presents close-up views of burned-through and erroded areas inside the thrust chamber. The inside of the combustion chamber was unusually clean of carbonaceous deposits—probably the result of oxidizer flowing through the chamber after the fuel had depleted. This chamber continued to blow down (flow propellants) for approximately fourteen seconds after the burn-through.

Figure 14—Inside views of 4.114 GG thrust chamber.

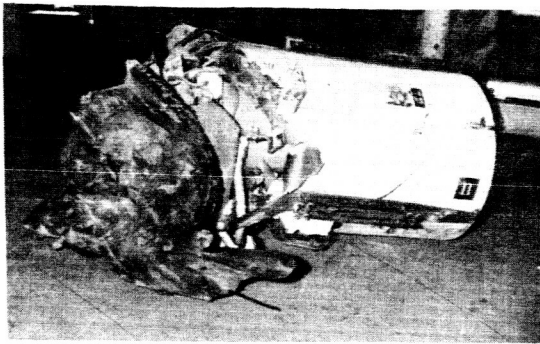
Figure 15 shows the tail section of the recovered sustainer for flight 4.112 NA. The fin roots are observed on the periphery of the sustainer tail can (painted white). The forward end of the thrust chamber (inside) is also noticeable. The chamber was in excellent condition considering the condition of the remainder of the sustainer. Figure 16 shows an external view of the thrust chamber with the sleeve assembly still in place. The "belly band" (white teflon strip) is improperly assembled. Also, the manner in which the pieces of the sleeve assembly fit together, and in which they fit to the thrust chamber nozzle was incorrect. These manufacturing anomalies did not contribute to the burn-through.

Figure 15—Flight 4.112 NA tail can damage.

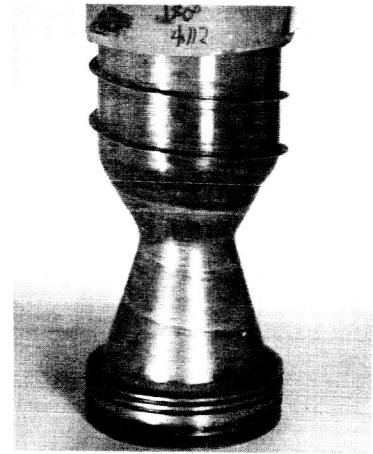
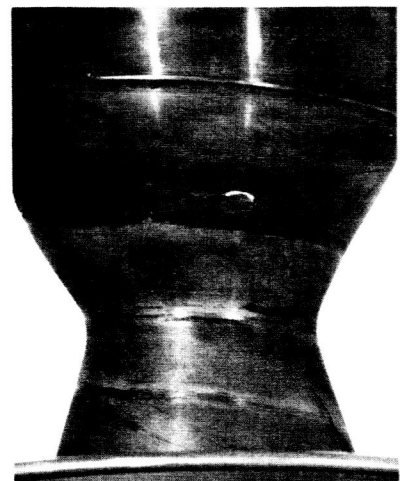
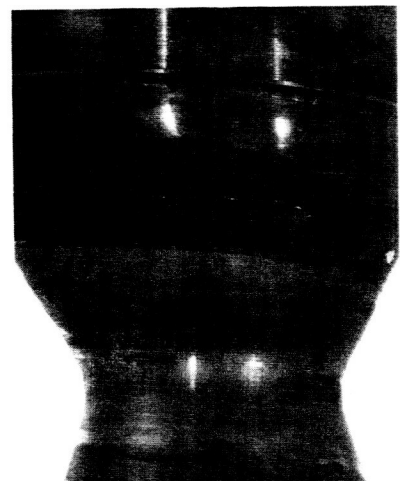
Figure 17a through 17c are external photographs of the 4.112 NA motor with the regenerative jacket and sleeve assembly removed. The burn-through is especially noticeable in Figure 17c.

Figure 17—External views of 4.112 NA thrust chamber.

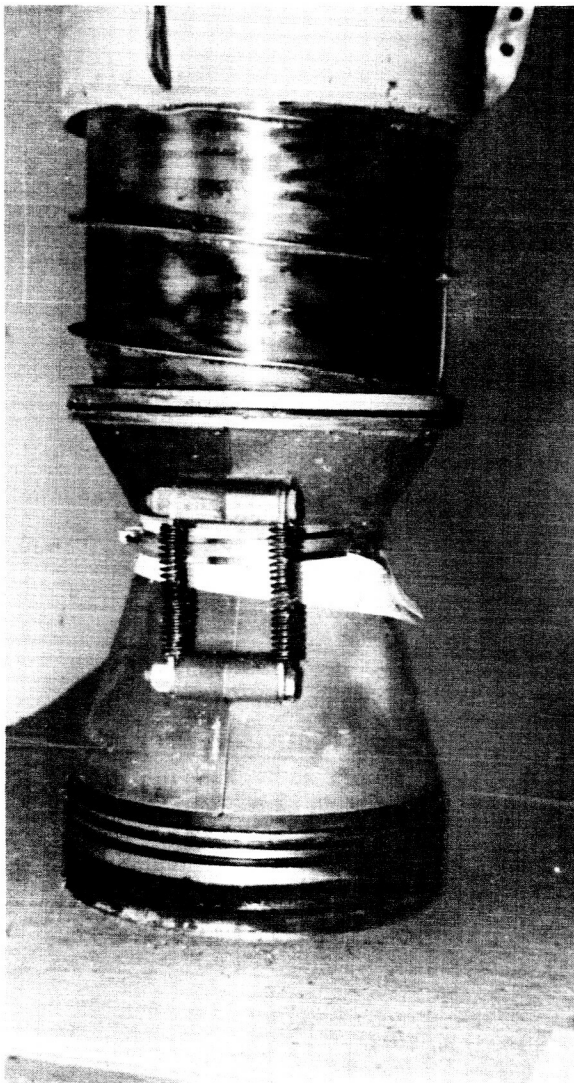
Figure 16—External view of 4.112 NA thrust chamber with throat blocks on.

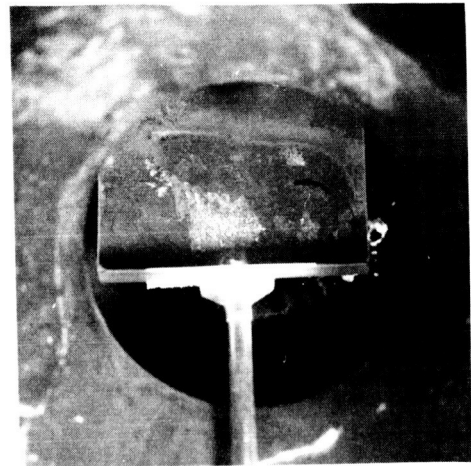
Figure 18 is an internal view of the burn-through and erosion which occurred in close proximity to each other. The carbonaceous deposits in the lower portion of the photo (in the divergent section of the nozzle) are normal.

It is possible that the burn-through on 4.112 NA was the result of fuel depletion, (i.e., if the thrust chamber uses all the fuel in combustion, there is no fuel left outside the chamber to cool it in the final second of burning.) Because of this possibility, the 4.112 NA burn-through must be considered apart from the burn-throughs on flights 4.126 GG and 4.114 GG.

Figure 18—Internal view of 4.112 NA thrust chamber burning.

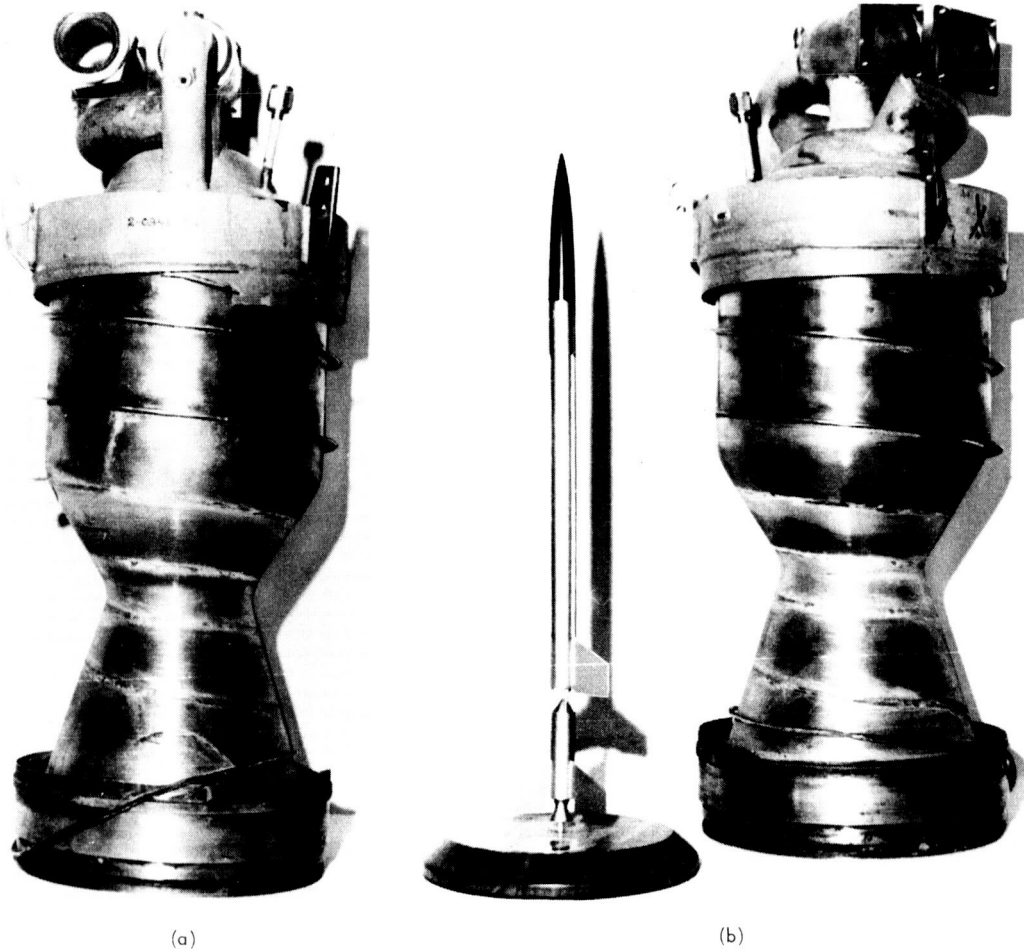
Figure 19—Burned areas of 4.88 GT thrust chamber.

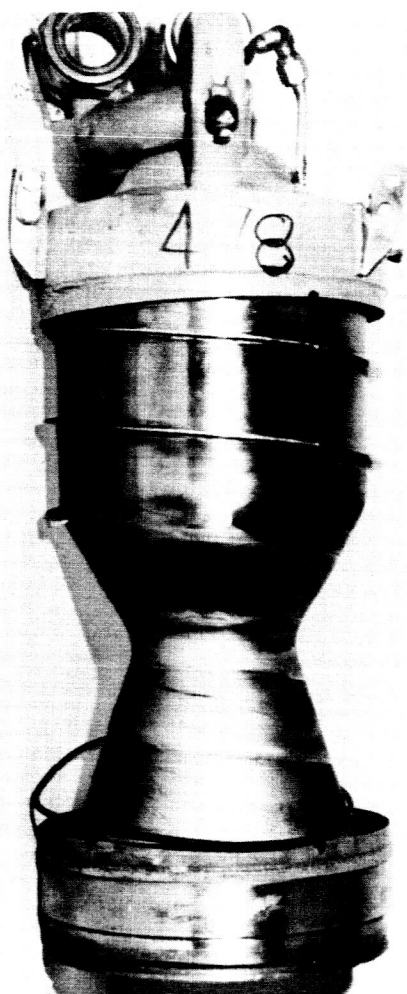
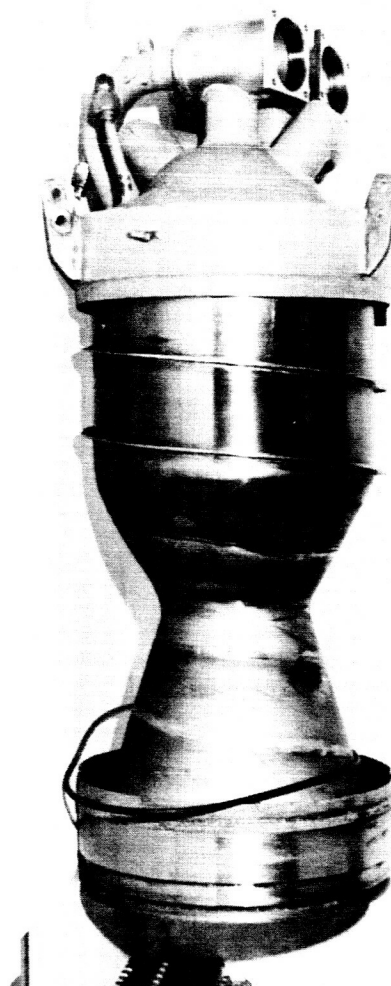
Figure 20—Burned areas of 4.78 GG thrust chamber.

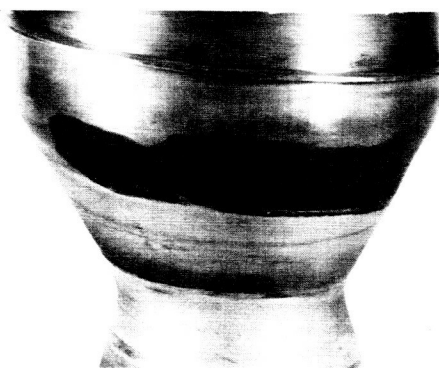
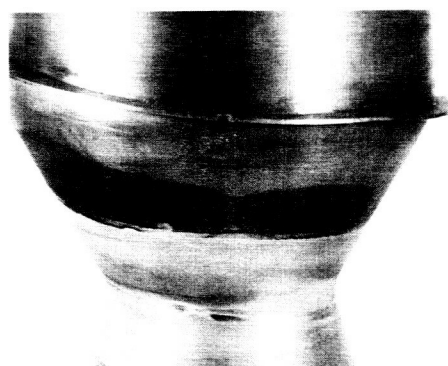
Figure 21—Burned areas of 4.110 GG thrust chamber

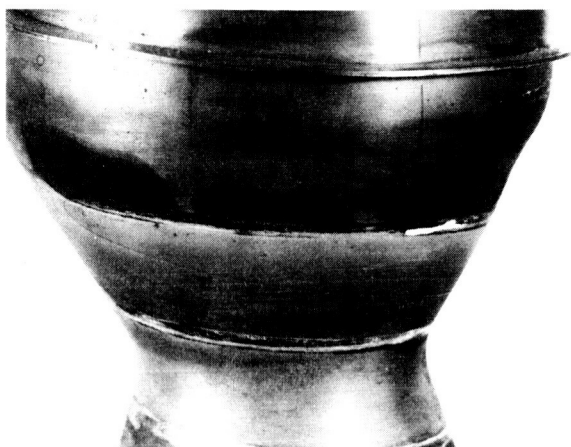
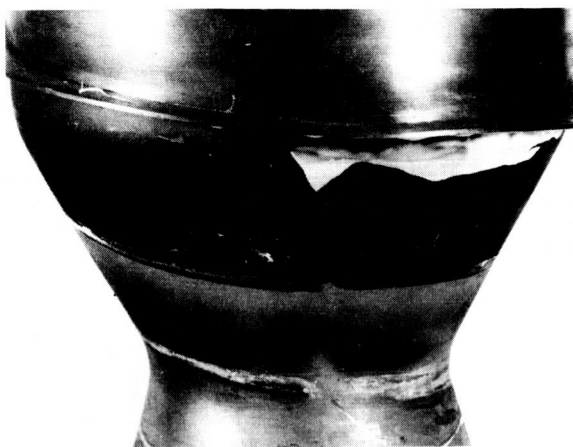
Figure 22—Burned area of 4.120 CG thrust chamber.

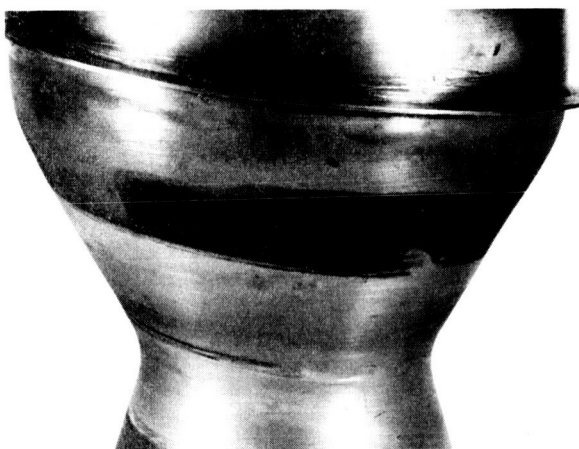
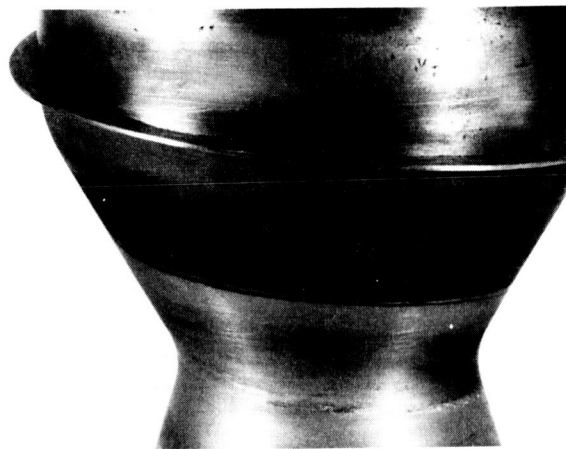
Figure 23—Burned areas of 4.123 CG thrust chamber.

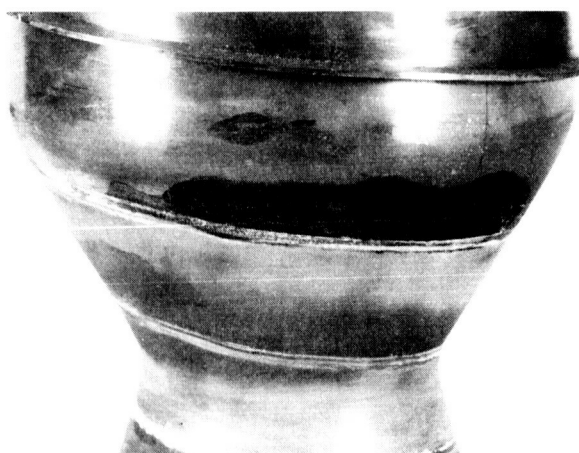
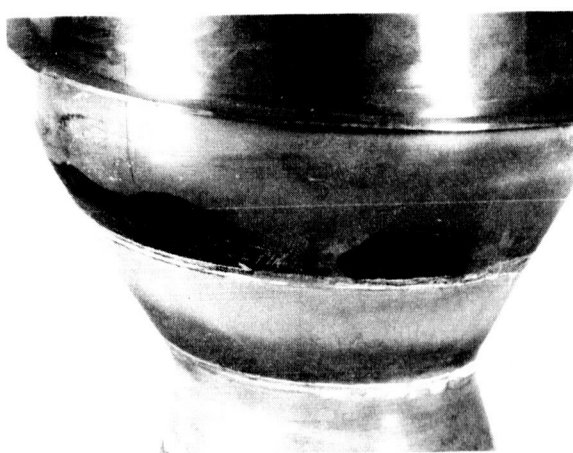
Figure 24—Burned areas of 4.132 GA-GI thrust chamber.

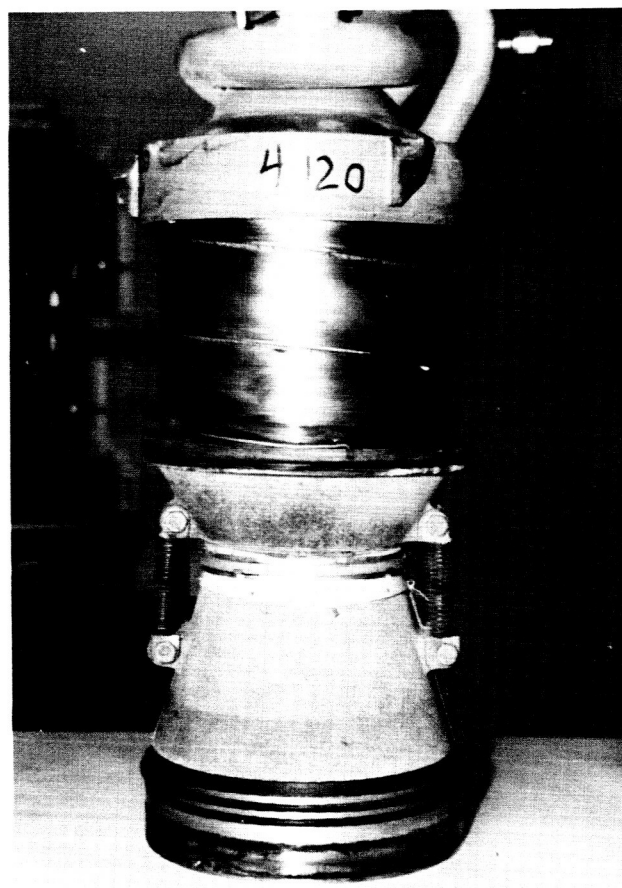
Figure 25—Thrust chamber of 4.120 CG with throat blocks on showing manufacturing discrepancy.

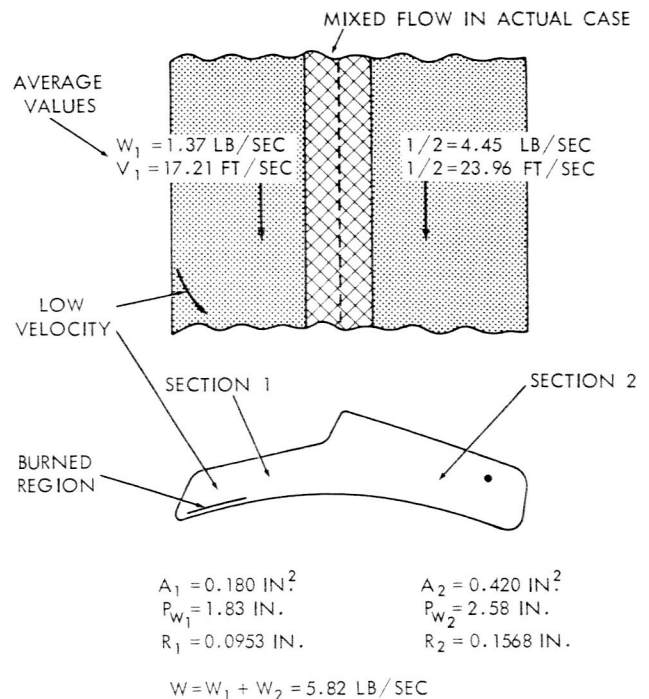
The following analysis of the velocity distribution in the cooling passage of Aerobee thrust chamber serial No. A-385 was undertaken as a result of a burn-through occurring in the convergent section of the nozzle during flight. Figure A1 shows a flow section of a geometry similar to that where burn-through occurred. The symbols used in this analysis are:

Figure A1—Cooling passage in region of burn-through.
